Searching for the Cause of Chinese Drywall Off Gassing

New Directions in
Sustainable Building Construction
for Architects & Builders

Certified Mold Free Corp.
Gary Rosen, Ph.D.

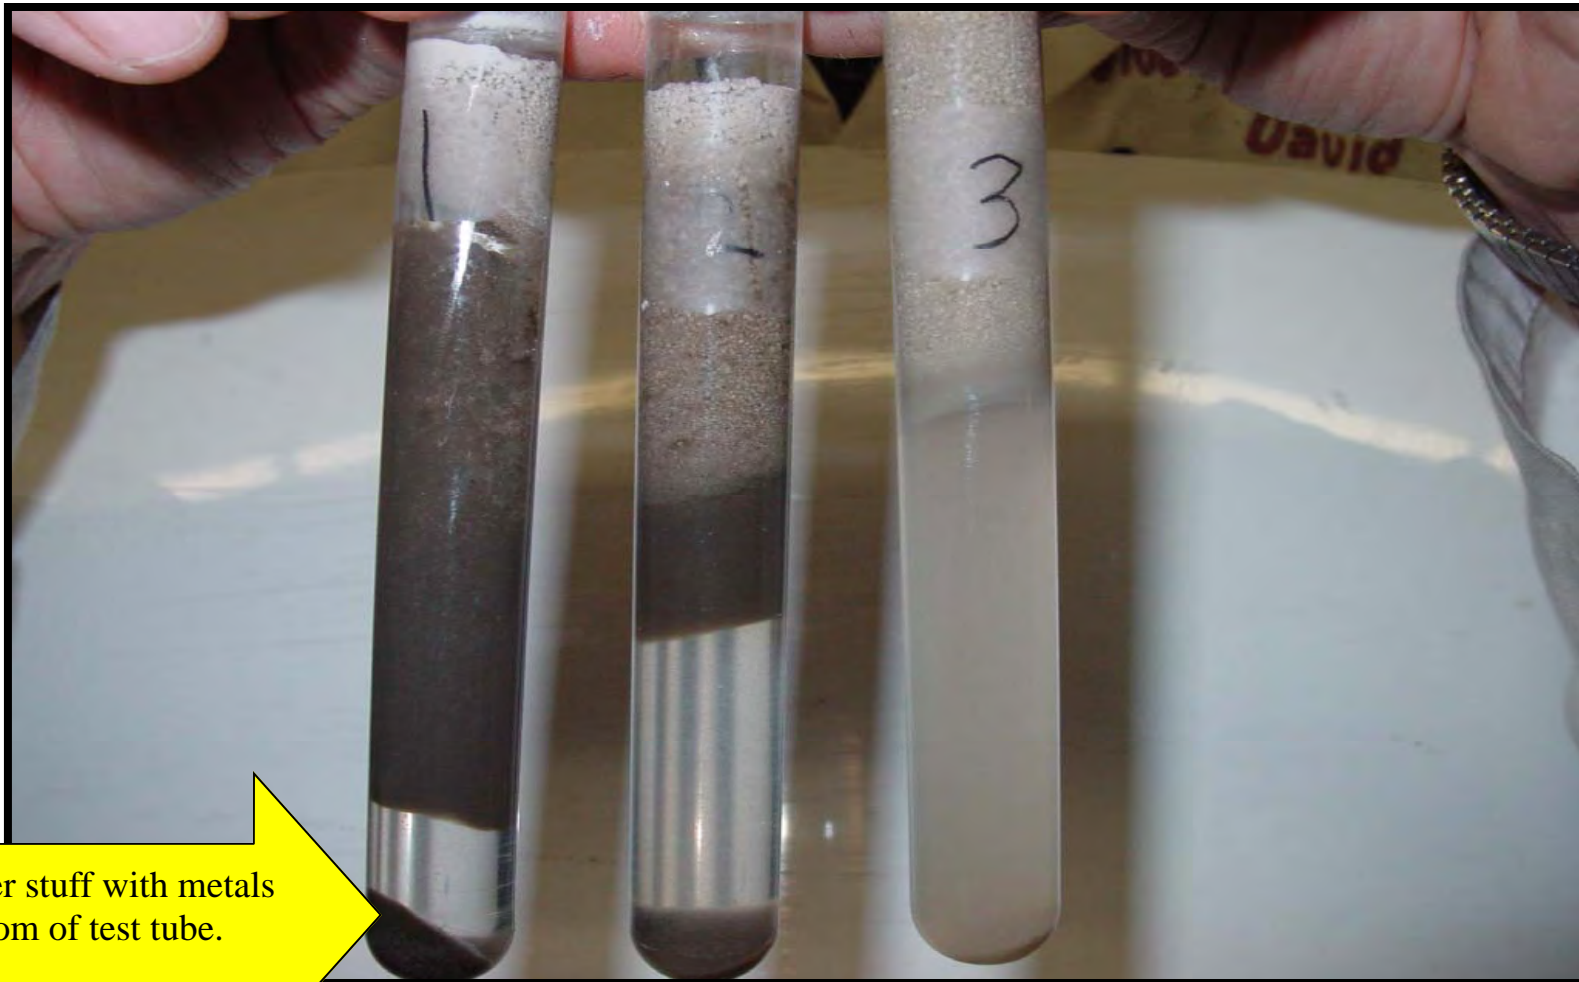
Heavier stuff with metals
at bottom of test tube.

- 1 BNBM 3-22-09 date code. The original drywall was a very slight grey color. The drywall had no smell.
- 2 BNBM No date code. The original drywall was a white color. The drywall had no smell.
- 3 USG 1/2" Very white color. The drywall had no smell. Not much impurity at the bottom of the USG drywall. Very clean.

On pages 3-5 we see pictures of test tubes containing 6 different types of ground up drywall. The pictures were taken after immersing the samples in a dense liquid and then spinning in a centrifuge. This procedure results in the separation of materials based on density.

This procedure produces a visual fingerprint that can be used to identify the different types of drywall. Clearly, all of these fingerprints are different. Knauf Tianjin is not the same as Knauf Natural, National Synthetic, or BNBM. Clearly there are two forms of BNBM one more pure than the other but neither looking like Knauf Tianjin.

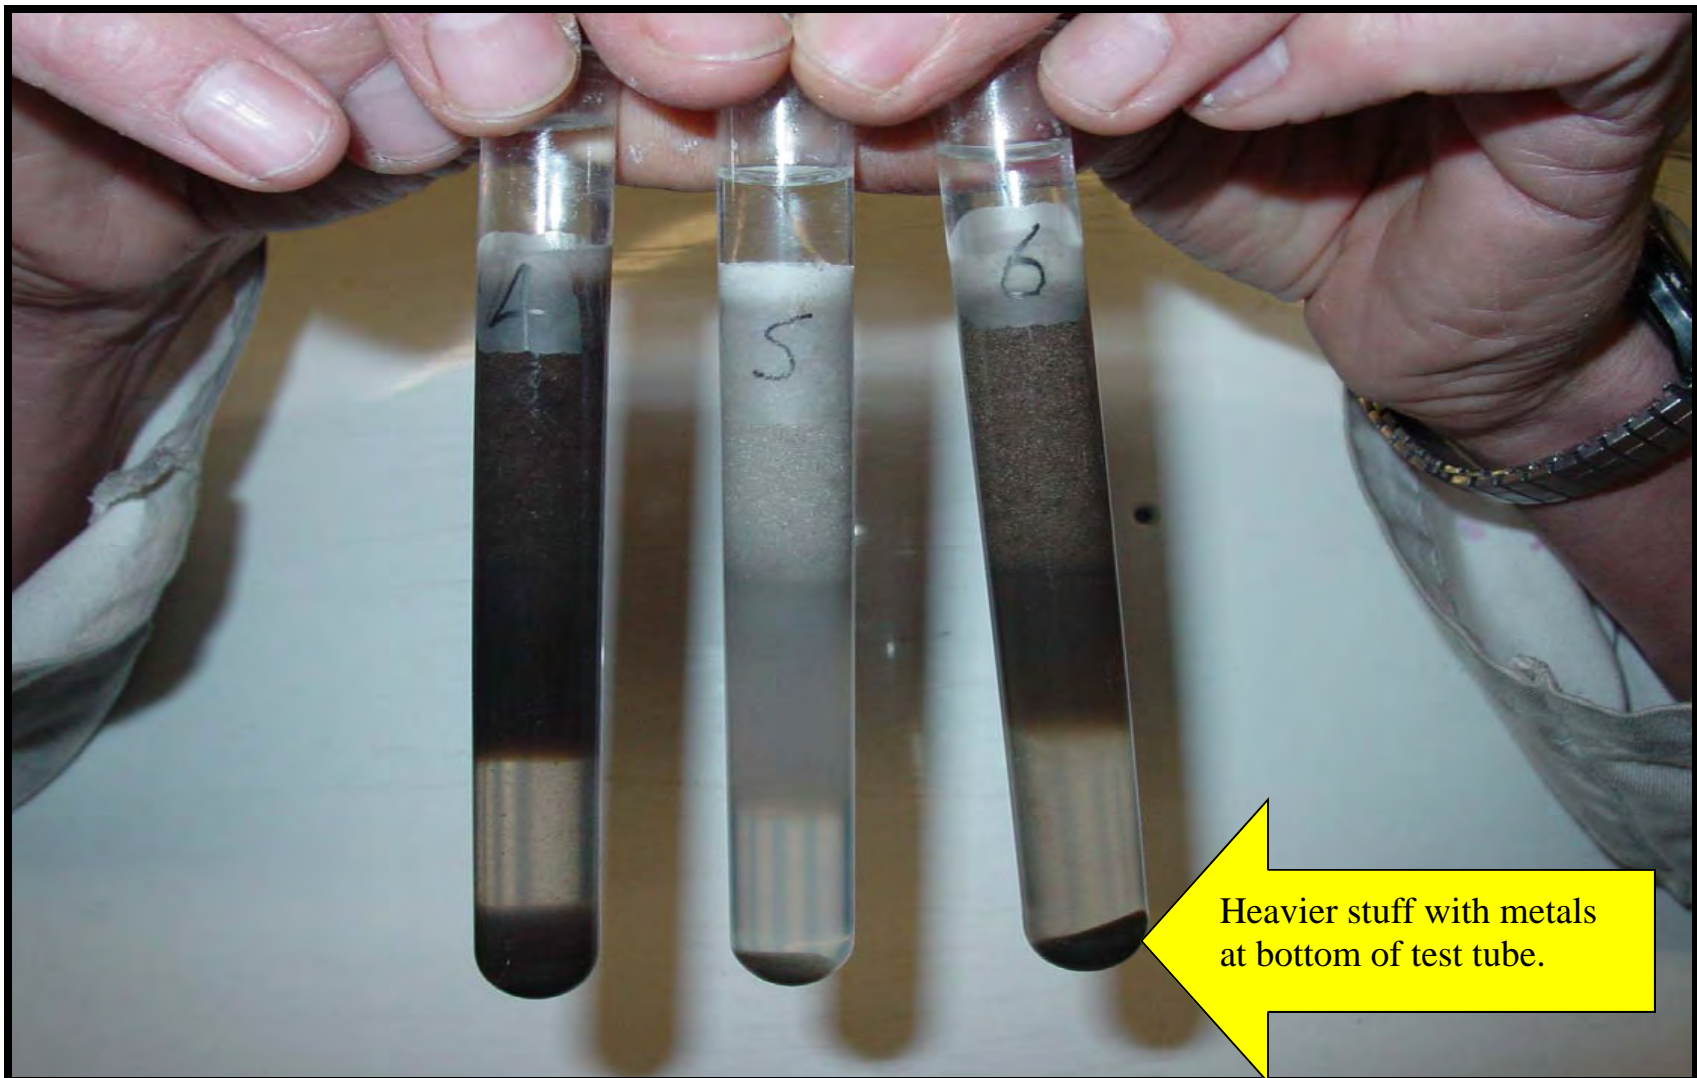
4 National Synthetic. Original drywall is grey in color. The original drywall had no smell. Bands are very dark in color.

5 Knauf Natural. Original drywall is very slightly grey in color. The drywall had no smell.

6 Knauf Tianjin. Drywall is grey in color. The drywall had a strong smell. Dark color to the bands.

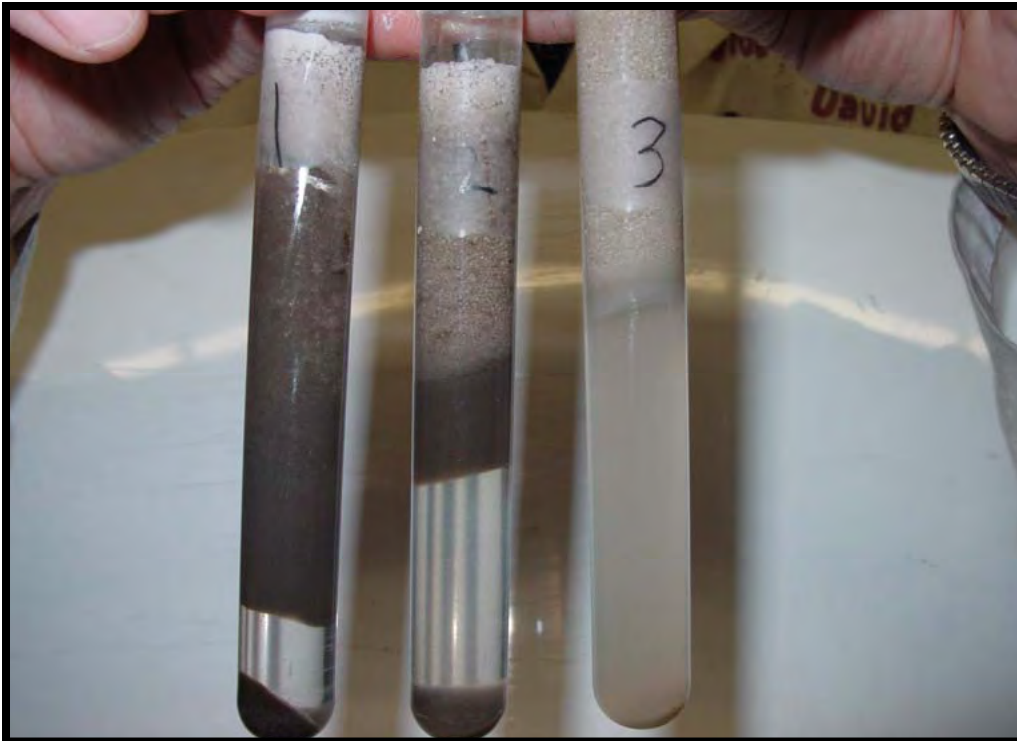
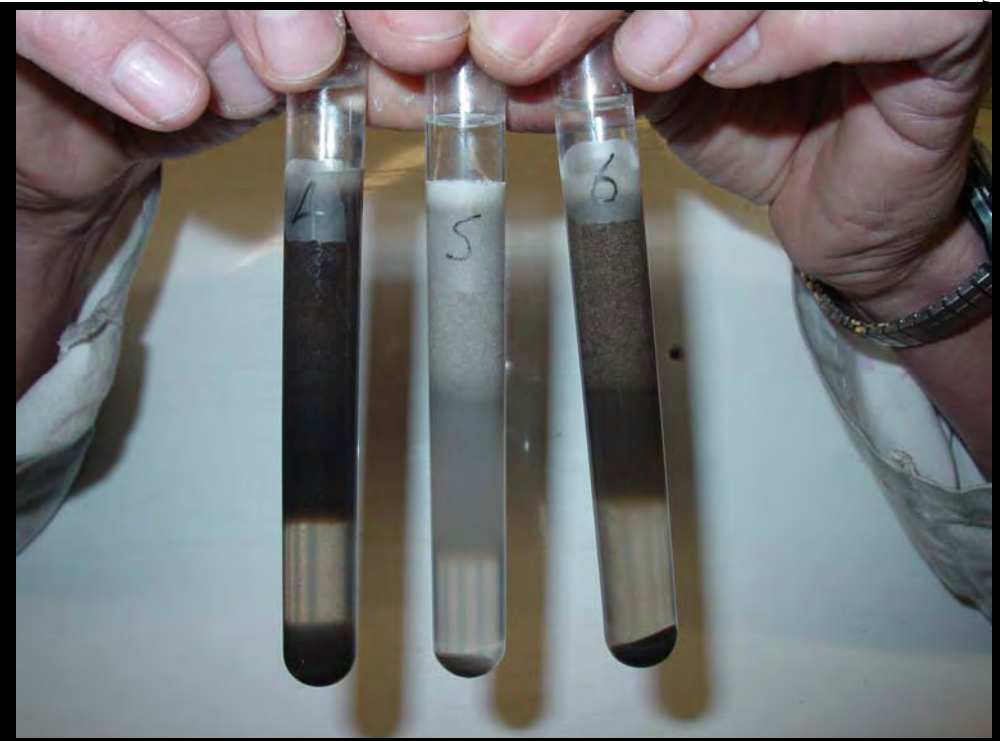
Clearly no two samples have the same material composition based on this analysis. All have different fingerprints. The bands are different in size and the colors are different. Next we will look to see what is in each of the bands. Results expected next month(Dec. 2009)

- 1 BNBM 3-22-09 date code.
- 2 BNBM No date code.
- 3 USG 1/2"
- 4 National Synthetic.
- 5 Knauf Natural.
- 6 Knauf Tianjin.

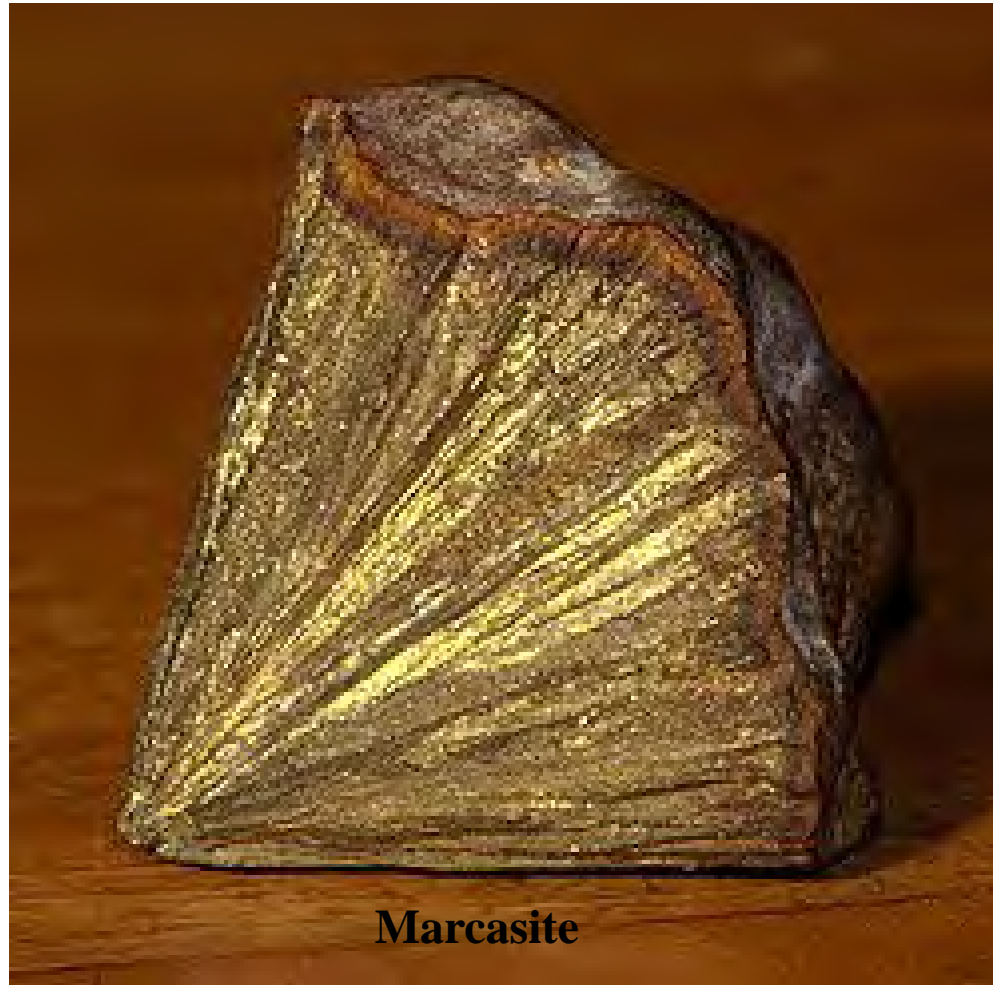
The mineral **marcasite**, sometimes called **white iron pyrite**, is iron sulfide (FeS_2). Marcasite is often mistakenly confused with pyrite, but marcasite is lighter and more brittle. Specimens of marcasite often crumble and break up due to the unstable crystal structure, and it is this crystal structure that is the main difference between marcasite and pyrite.
